**PRELIMINARY REPORT OF
RAINFALL EVENT, NOVEMBER 21-26, 1984
SOUTH FLORIDA COASTAL AREA**

South Florida Water Management District

December 1984

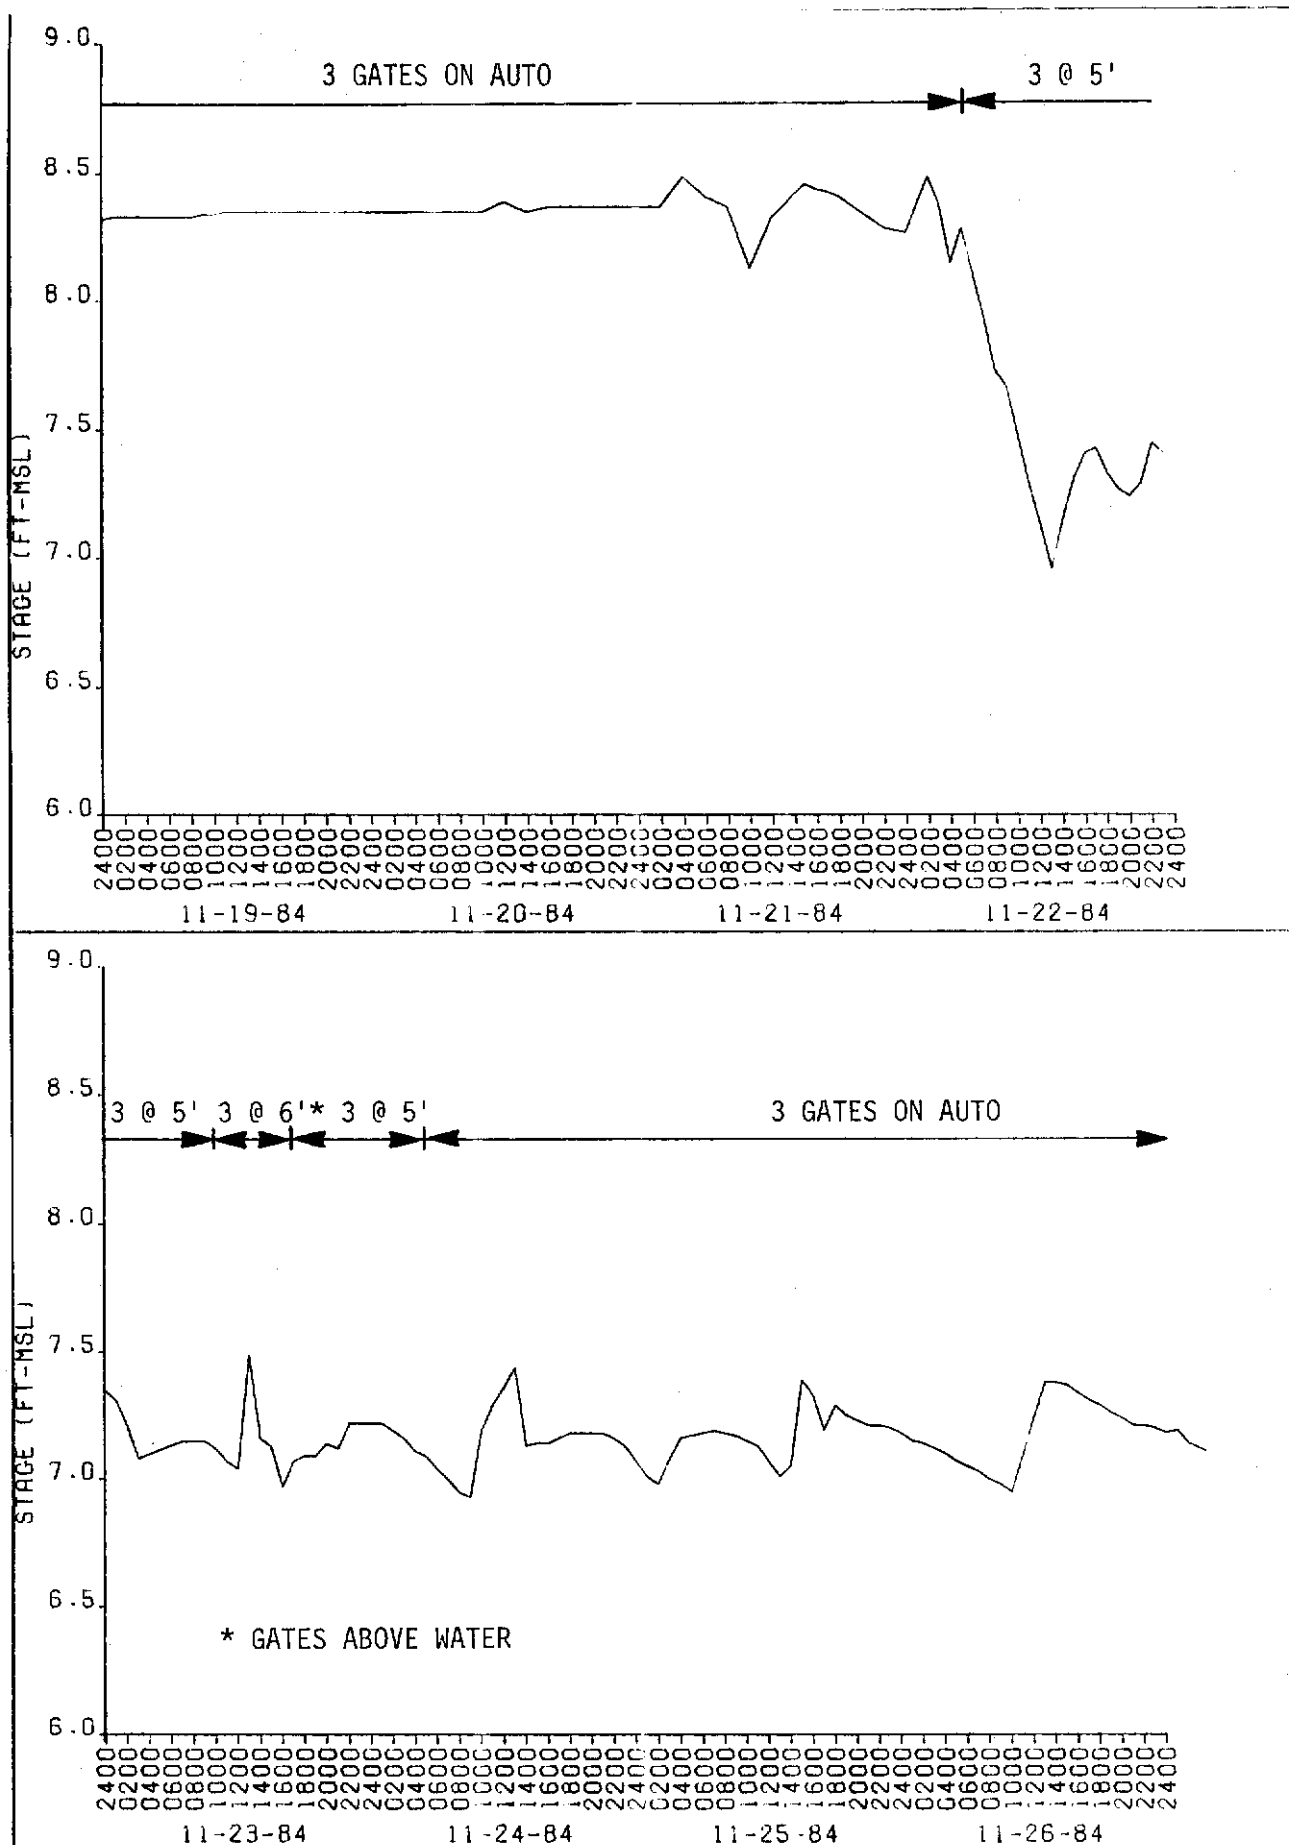
FIG. 8 HOURLY STAGE READINGS AT S-155HW

The headwater stage was between 8.0 to 8.5 ft above mean sea level. After the storm started, the stage was lowered to 7.0 ft msl to facilitate the inflow from the West Palm Beach Canal basin. The details of the operation are presented in Table 4. The stage at the headwater of S-155 reached 8.49 ft at 2 a.m. on November 22, 1984. The hourly stage hydrograph with gate operations is presented in Figure 8.

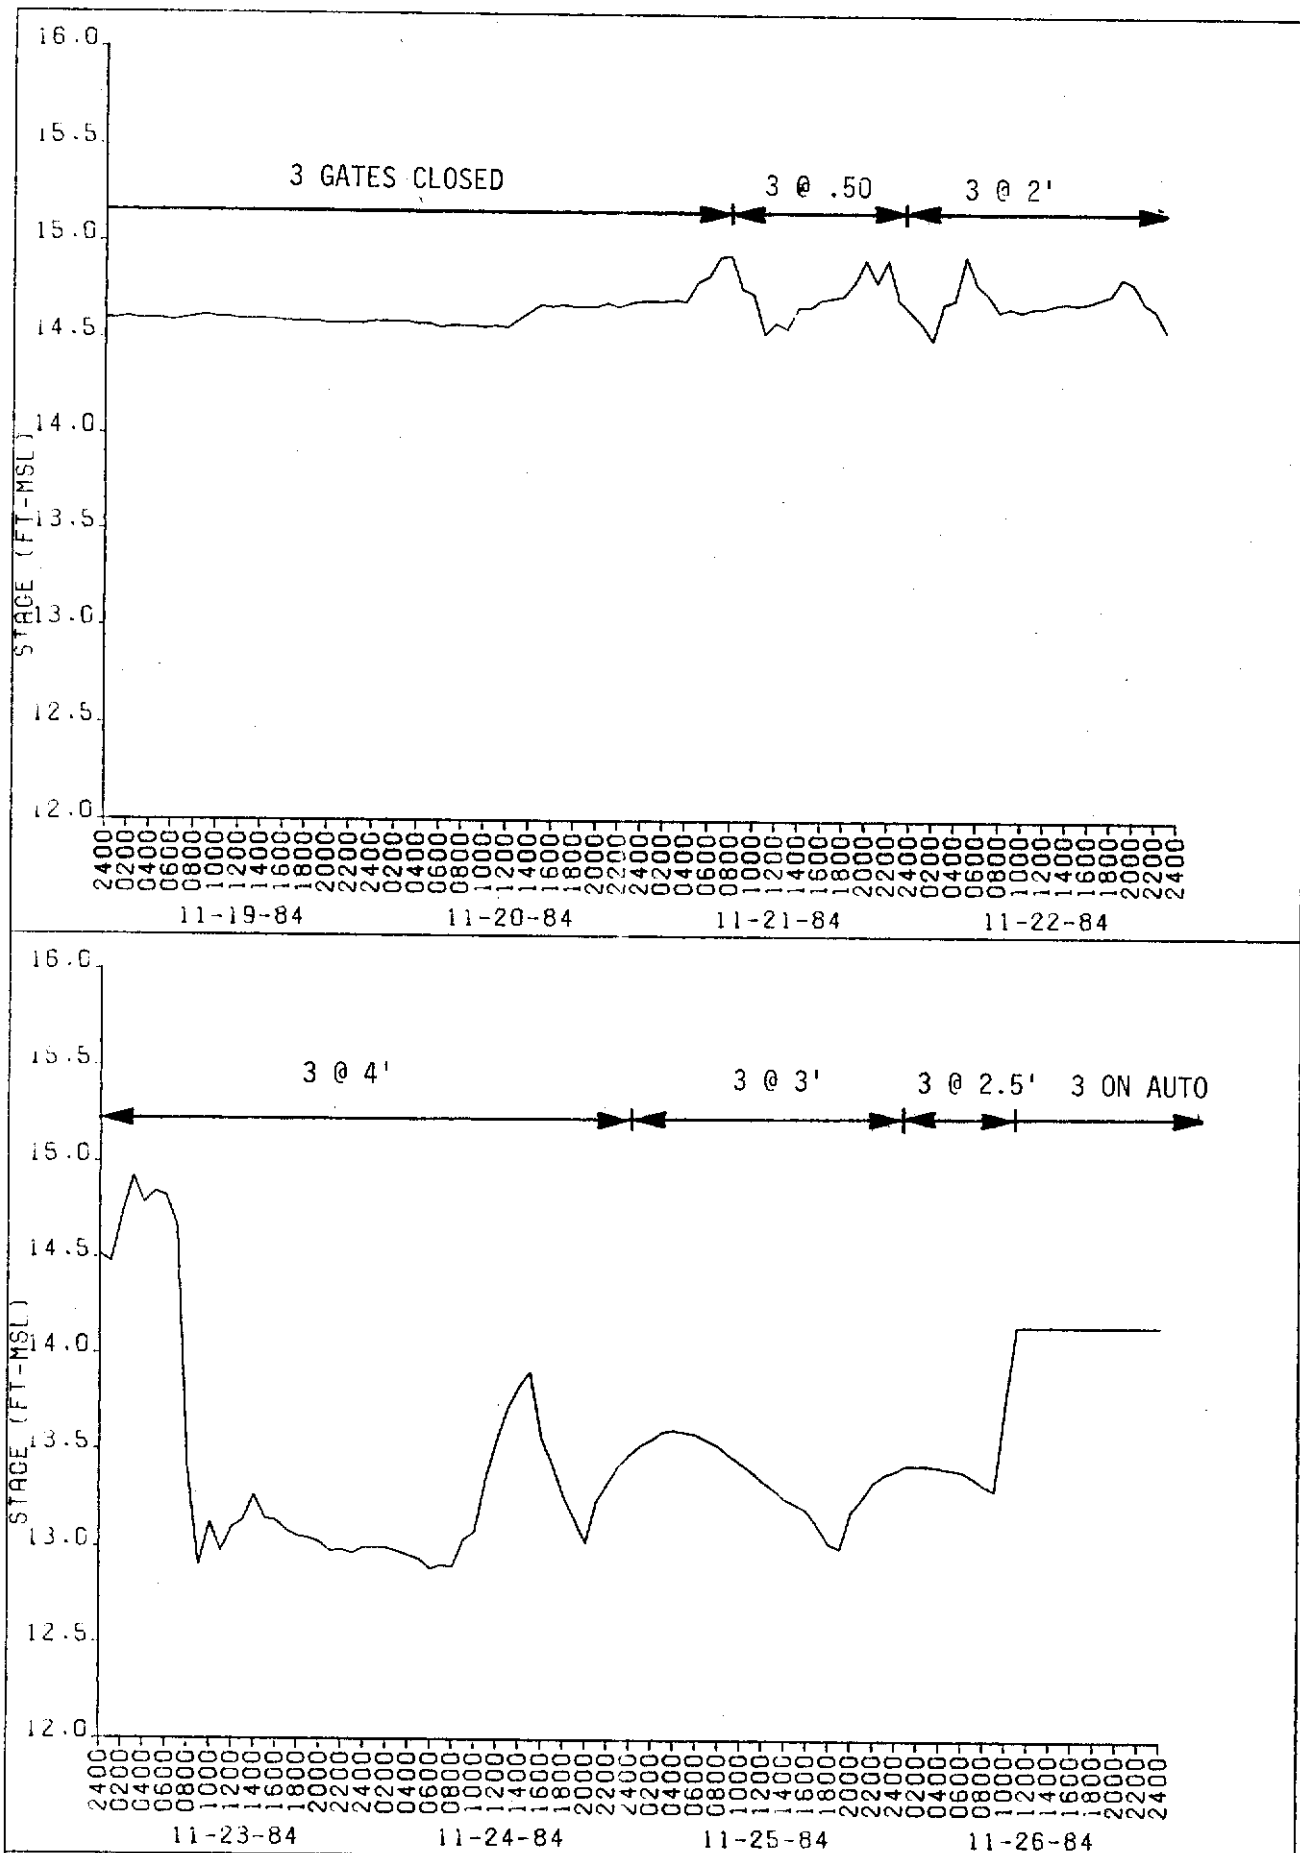
FIG. 11 HOURLY STAGE READINGS AT S-46HW

The gates were on automatic and maintained the headwaters of S-46 at 14.5 ft to 15.0 ft msl. At 0530 hours November 22, the No. 2 gate was not operating properly and was repaired by the District's electrician. The stage was maintained at 14.5 to 15.0 during November 22. At 2200 hours November 22, the upstream and downstream stages at C-18 weir located just north of Beeline Highway bridge, were at 18.6 and 16.0 ft msl respectively. The critical downstream stage at the C-18 weir is 17.6 ft msl. In response to the heavy rainfall along the coast, the S-46 headwater was lowered to 13.0 ft msl in the morning of November 23. The upstream and downstream stages at the C-18 weir were 18.55 and 16.54 ft msl, respectively, at 1123 hours November 23. The gates at S-46 were maintained on manual until 1300 hours November 24. The headwater stage was put back on automatic low setting to maintain stage between 13.0 to 14 ft msl. Figure 11 shows the hourly stage hydrograph with gate operations.

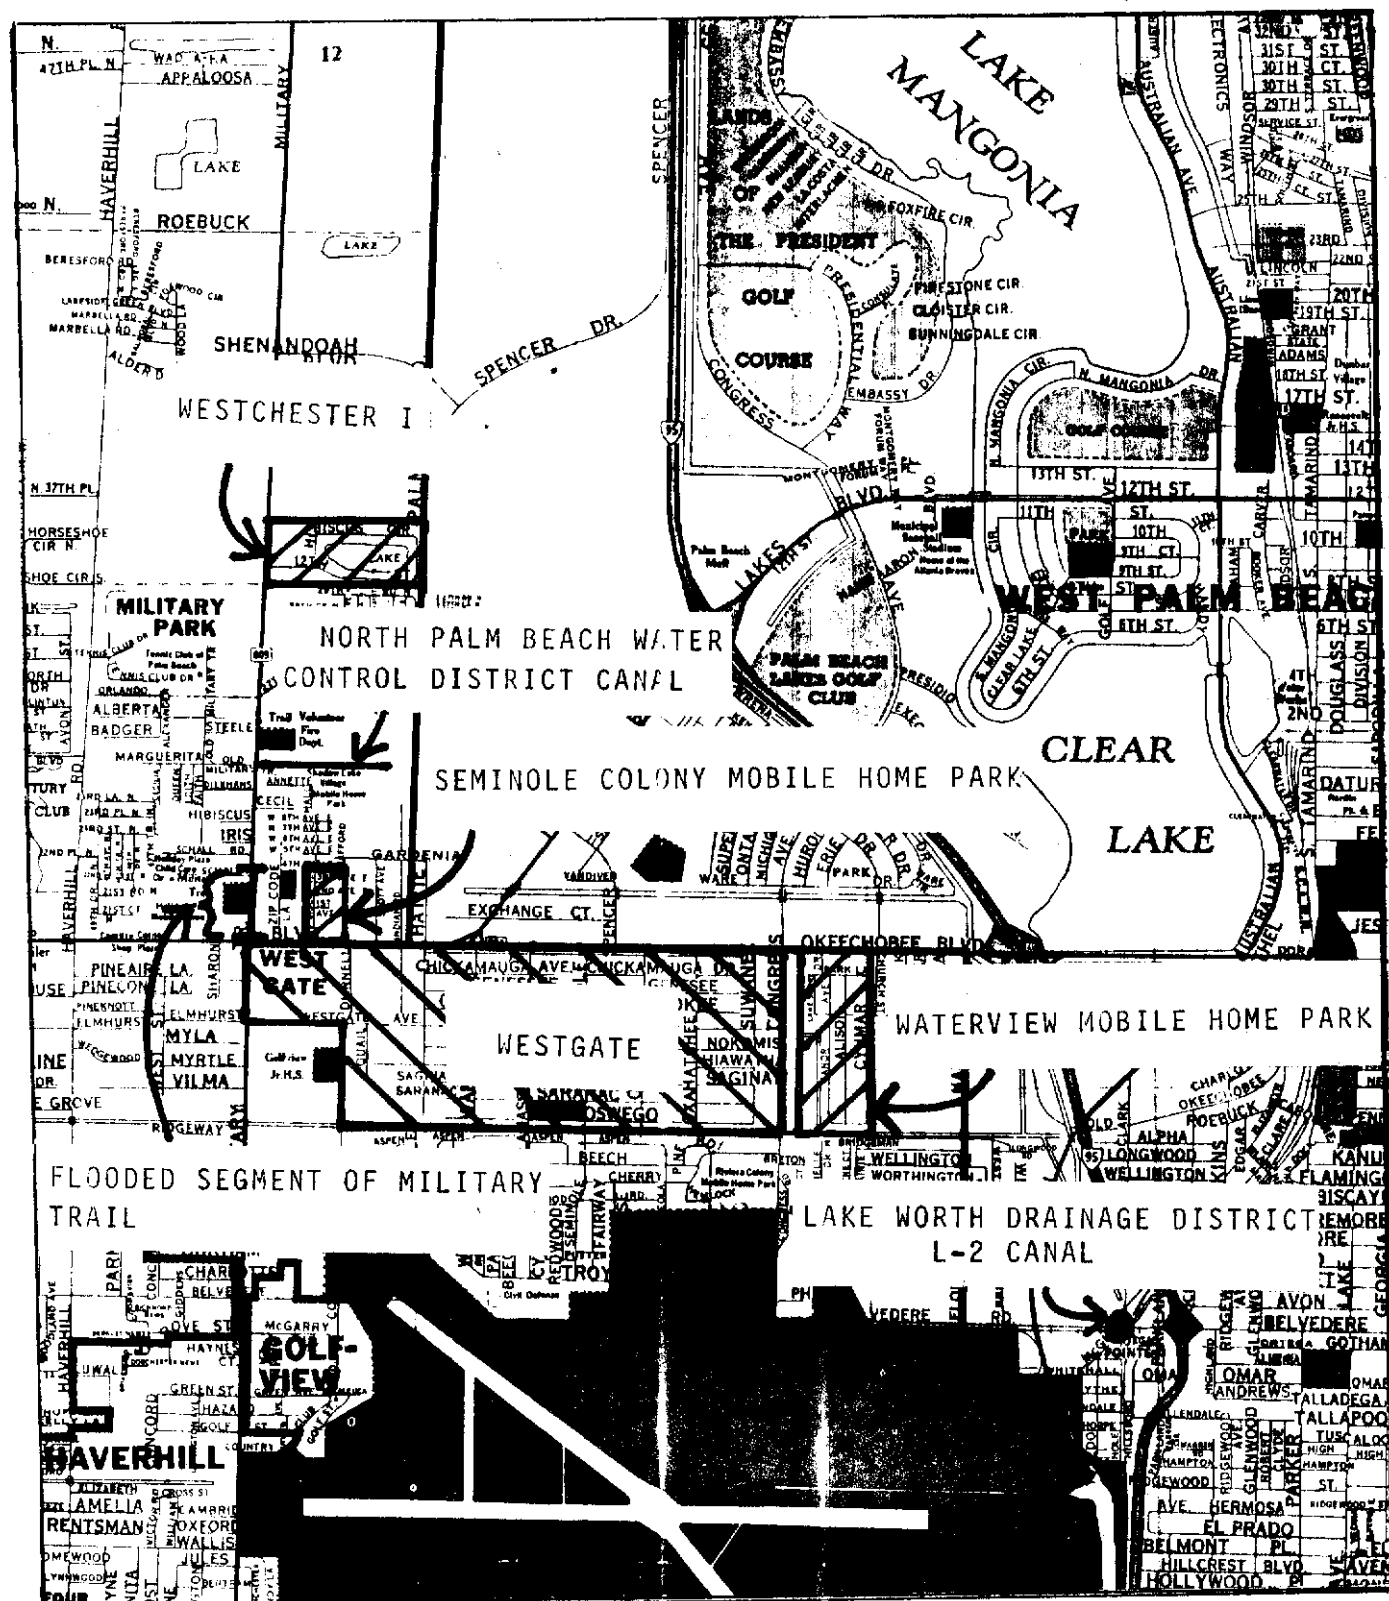
FIGURE 12

Seminole Colony is located approximately three-eighths of one mile east of Military Trail on the north side of Okeechobee Boulevard. It was inspected at 0907 hours on November 22. Extensive lot and road flooding was observed throughout the project. Water approximately 2 feet deep was observed along the centerline of the entrance road to the park. At least one trailer was flooded. District field representatives were told by residents of Seminole Colony that the mobile home park drains directly into the Northern Palm Beach County Water Control District (NPBCWCD) canal which is located approximately one-half mile north of the park. Locating and inspecting the park's drainage system was not possible due to the areal extent of the flooding. There are several factors which could have contributed to the flooding. The park is at a low elevation relative to a commercial warehouse project under construction, immediately adjacent to Seminole Colony, on the west side. In addition, debris lines indicated that water had sheetflowed from Okeechobee Boulevard north into the project. Finally, the NPBCWCD canal which received water from the project appeared to be at capacity.

Flooding occurred on Military Trail in the vicinity of the Military Trail School, just north of Okeechobee Boulevard. This area was inspected at 0925 hours on November 22. Water extended to the western edge of the northbound lane for a distance of approximately 400 ft. This water was a couple of inches deep and did not prevent traffic from using the roadway.

This canal follows an east-west alignment and drains into the EPB-11 canal. It is located approximately 0.5 mile north of Okeechobee Boulevard and runs along the south side of the Northwood Institute. At 0926 hours on November 22, the canal stage was observed to be about 1 foot below the top of the south bank and was even with the elevation of the north bank. Water was observed to be sheetflowing into the canal through the undeveloped areas along its south bank.

This area was constructed under General Permit No. 81-36, and is located one mile north of Okeechobee Boulevard on the east side of Military Trail. The area was inspected at approximately 0935 hours on November 22. The detention lake stage was over the banks. A water depth of 0.5 foot was measured over the centerline of Woodstock Drive at the entrance to the development. No house pads were flooded; however, the road flooding was extensive. The operation of the development's water control structure could not be evaluated since high water stages in the NPBCWCD system prevented the water from draining.

Waterview Mobile Park is a development located on the south side of Okeechobee Boulevard, approximately 500 feet east of Congress Avenue. This area was inspected at approximately 0955 hours on November 22. The majority of the roads in the project were under water. Several automobiles were flooded. At the time of inspection, water was 1.6 feet deep over the centerline on Manor Avenue. Watermarks indicated that several mobile homes had been flooded hours earlier. The drainage system within Waterview Mobile Park consists of a series of drop inlets, aligned along an inverted road crown, which drains into Lake Worth Drainage District (LWDD) Lateral Canal No. 2 (L-2). At the time of inspection, the water in the L-2 canal was out of its banks.

This canal follows an east-west alignment and is located approximately one-half mile south of Okeechobee Boulevard. This canal eventually drains into C-51. The L-2 canal was inspected at 1023 hours on November 22 at the point where it passes under Belvedere Road. At that time, the stage within the canal was 5.8 feet below the bottom of the electrical conduit on the south side of the bridge. The observed flow was in a southerly direction.

This development is located east of Military Trail, between Belvedere Road and Okeechobee Boulevard. It is bounded on the east by Congress Avenue. This area was inspected at approximately 0900 hours on November 22. General road flooding was observed throughout the entire community. Intersections along Westgate Avenue had water standing 2 feet deep. The roadway and parking lot

of the Westgate Community Center were under water. Several homes in the area were observed to have water inside. The Westgate school grounds were flooded with water to within 1 inch of the floor elevation. Water in the LWDD L-2 canal was flowing with a stage 3 feet below the top of the bank.

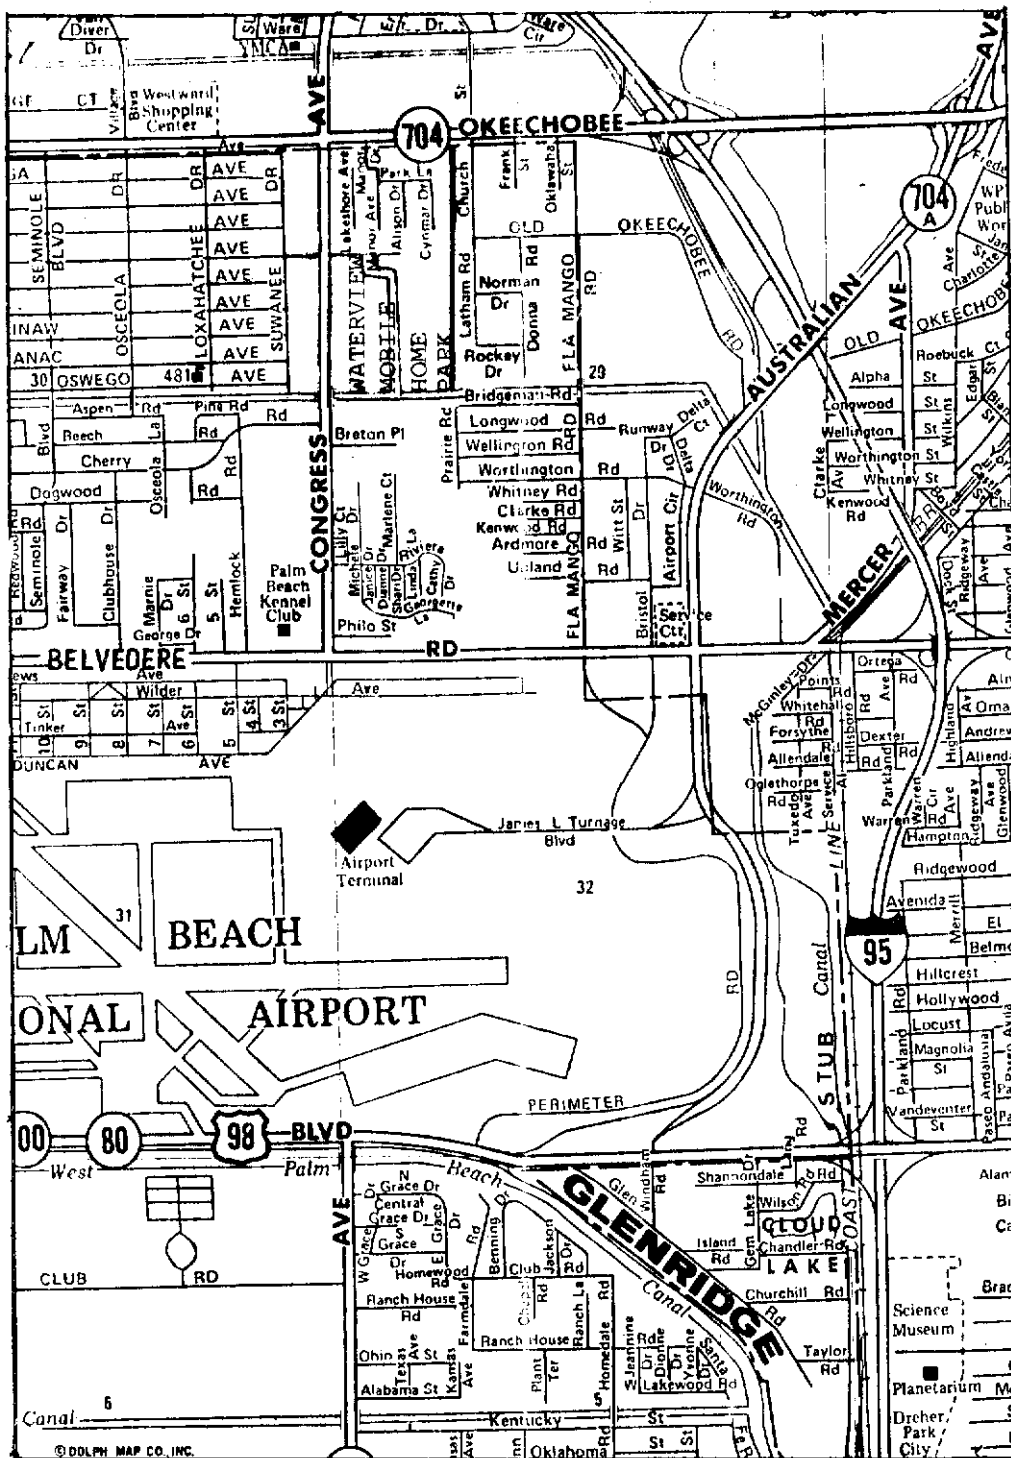
FIG. 13

The flood stage in Waterview Mobile Park probably was higher than the peak stage during the April 23-26, 1982 rainstorm; however, it was much less than previous storms as shown in Table 3. It should

- C. The Waterview Mobile Park is located on a relatively low land area. The ground elevation at the southwest corner of the park, on a catch basin, is at 9.76 ft msl, and the center line of Manor Street at 1616 Manor is at 10.90 msl. In general, the ground elevation of the mobile park area is below 12.5 ft msl, while the surrounding areas were developed above an elevation of 15.0 ft msl. Therefore, the mobile park receives runoff from the surrounding area which is a raised and paved industrial area.

Glen Ridge is a development near the southwest corner of I-95 and Southern Boulevard. This project was inspected at 1032 hours on November 22. Road flooding was observed in several areas of the development. Several homes appeared to have water inside. Glen Ridge has a drainage system which depends on a pump. At the time of the inspection, District field representatives were told that the pump had been inoperable for about 1.5 hours.

In view of the possible adverse impact to the existing C-51 basin, it is not feasible to improve this reach of channel cross-section. Instead, it may be more feasible to consider a small pumping station and a flap gate control culvert to relieve the Waterview Mobile Park from frequent flooding. This would require a levee to protect the park area. Drainage would be to Lateral Canal #2 (L-2) of the Lake Worth Drainage District. The normal stage in L-2 is approximately 8.5 ft msl. The gated culvert should maintain a normal stage inside of the park of less than 9.0 msl. The pump should start up automatically at a stage of 9.5' msl and shut off at a stage of 9.0 ft msl.

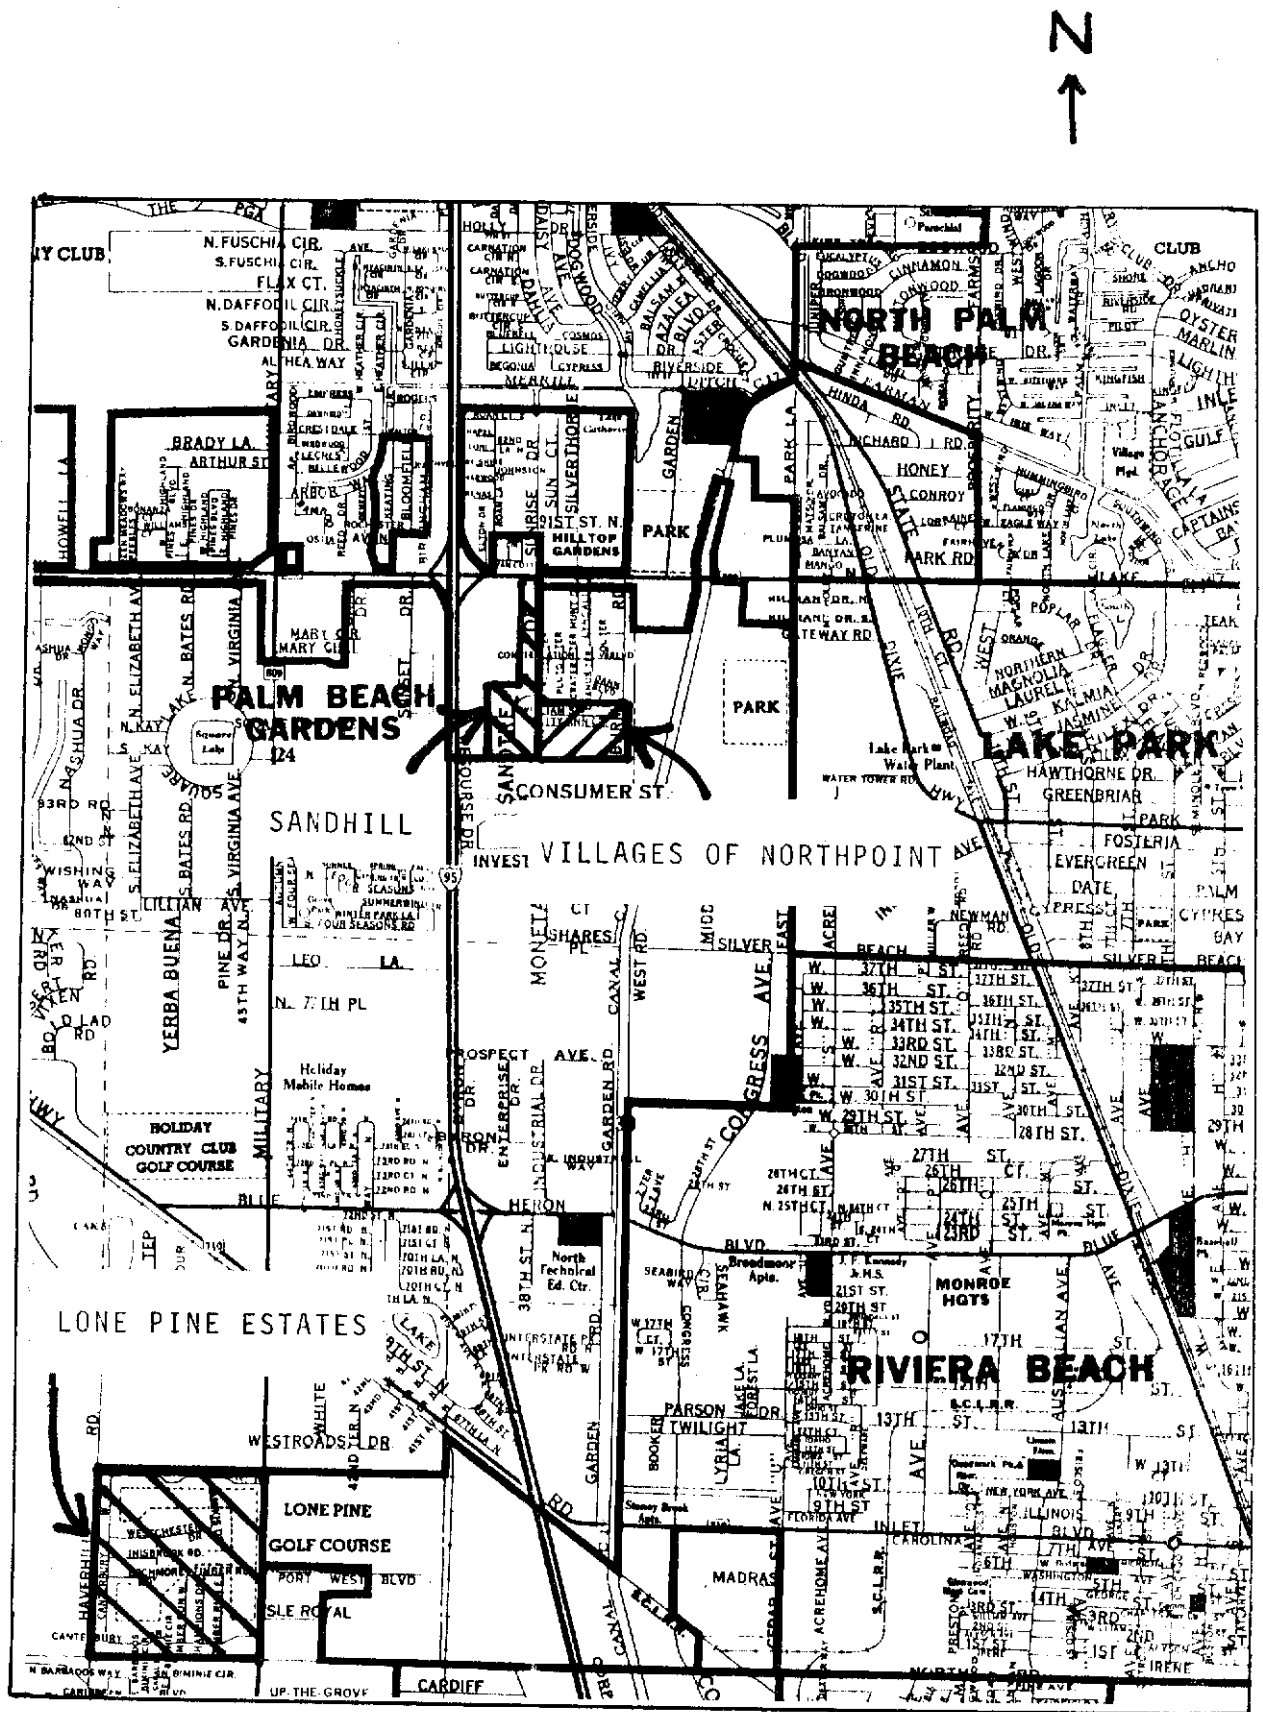
FIGURE 14 LOCATION OF SANDHILL, VILLAGES OF NORTHPOINT AND LONE PINE ESTATES

Sandhill is a development located east of I-95 and south of Northlake Boulevard. It was inspected at 1413 hours on November 23. The project's retention area was not full, and the roads and swales were dry. An additional retention area, which is shared with the Villages of Northpoint, had approximately 0.2 foot of water over its banks.

This development is located just east of Sandhill. It was inspected at 1415 hours on November 23. Flooding was observed along some of the roads. The retention area shared with Sandhill was out of its banks.

This development is located west of Military Trail, north of 45th Street. It was inspected the afternoon of November 23. Flooding was extensive. At least one home was flooded. No discharge to EPB-9 and 10 canals was possible due to high water stages in those canals.

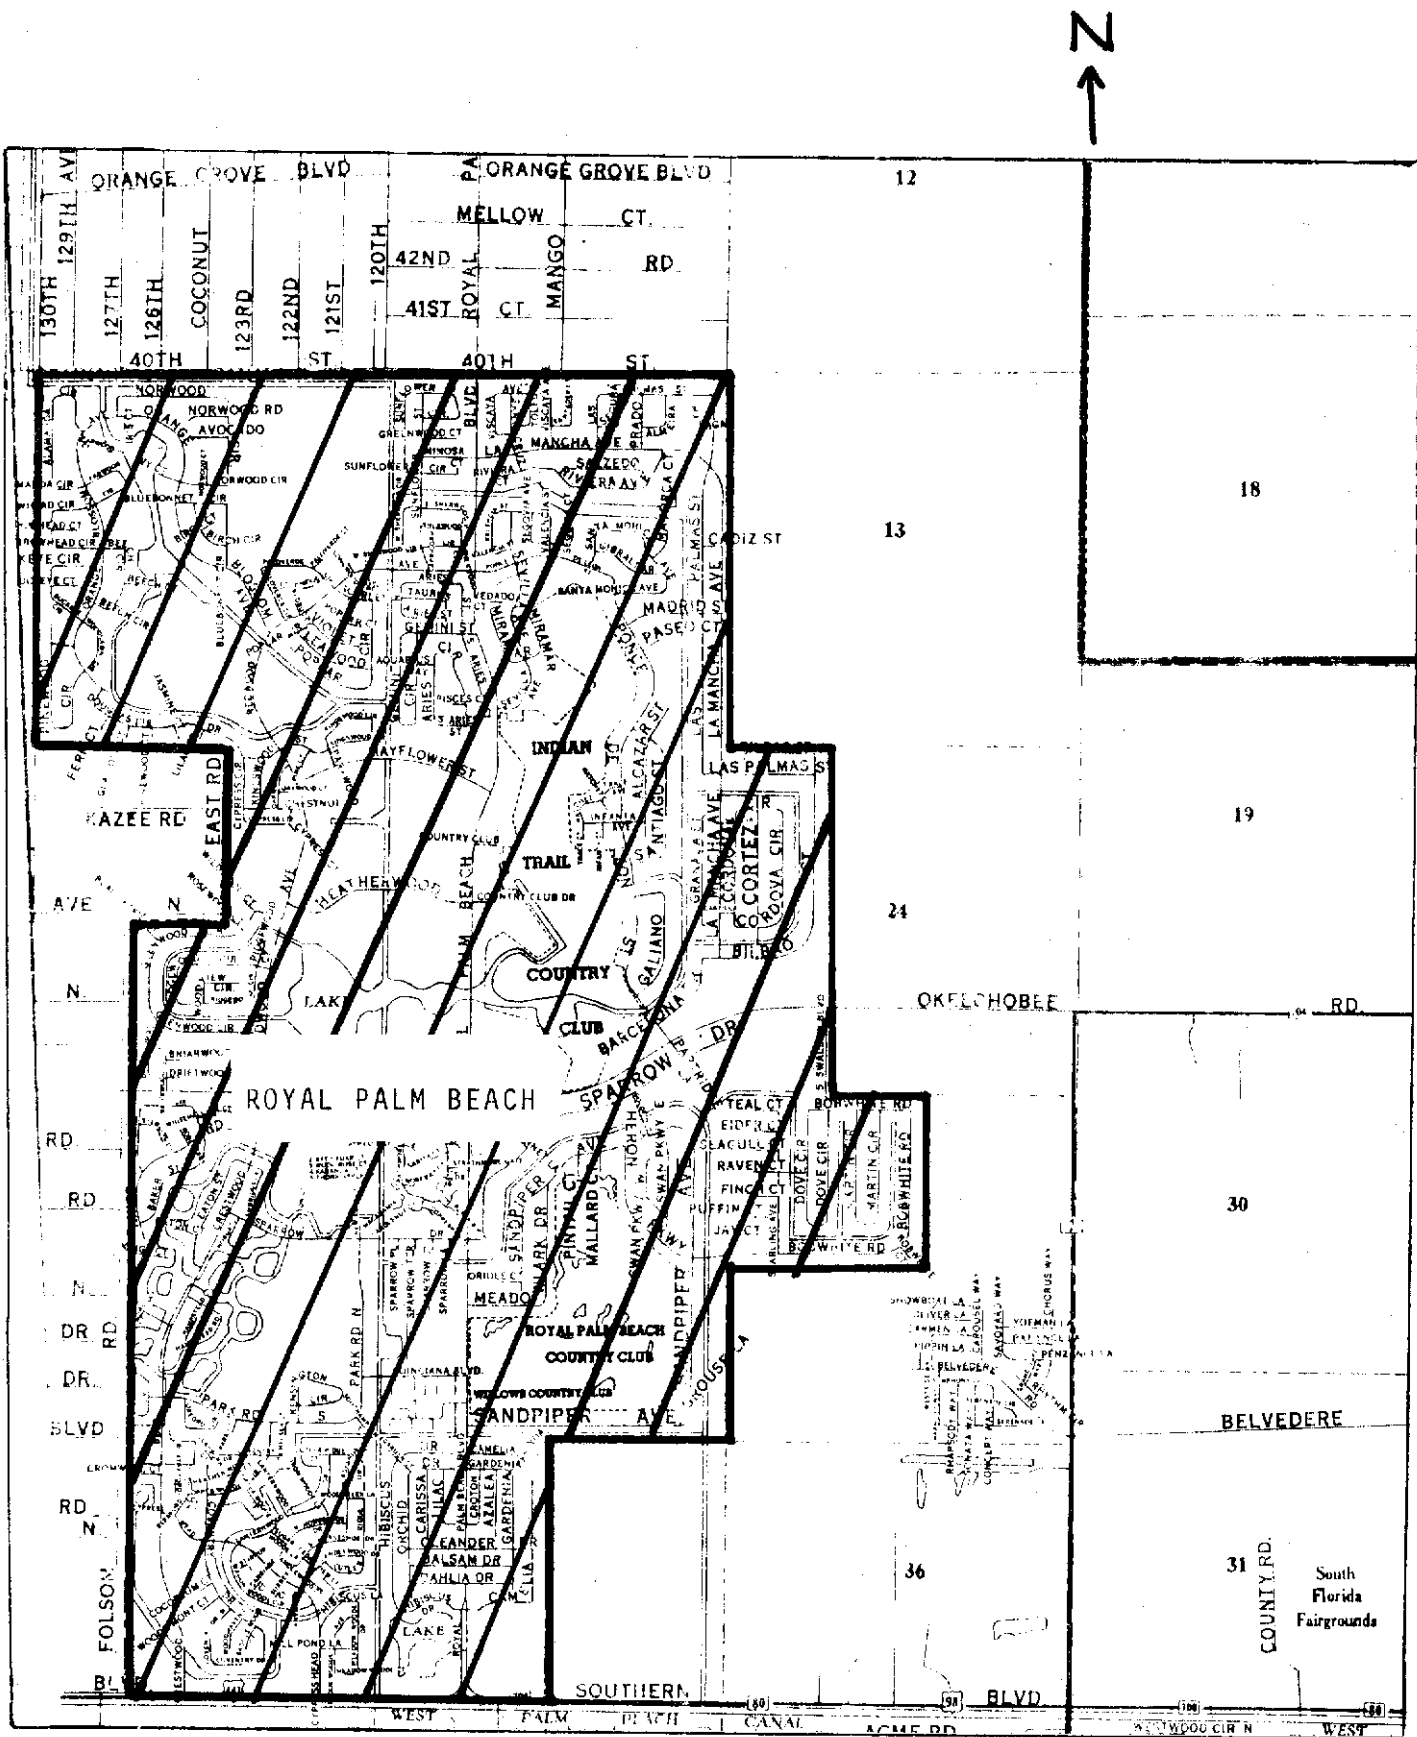
FIGURE 16 LOCATION OF ROYAL PALM BEACH

This area is located west of SR-7 and north of SR-80. This community was inspected during the afternoon of November 23. Some minor yard and street flooding was observed. The stage in the M-1 Canal of the Indian Trail Water Control District was 3 to 4 feet higher than the stage in C-51 at the Amil gate, the main outlet of Royal Palm Beach Village.

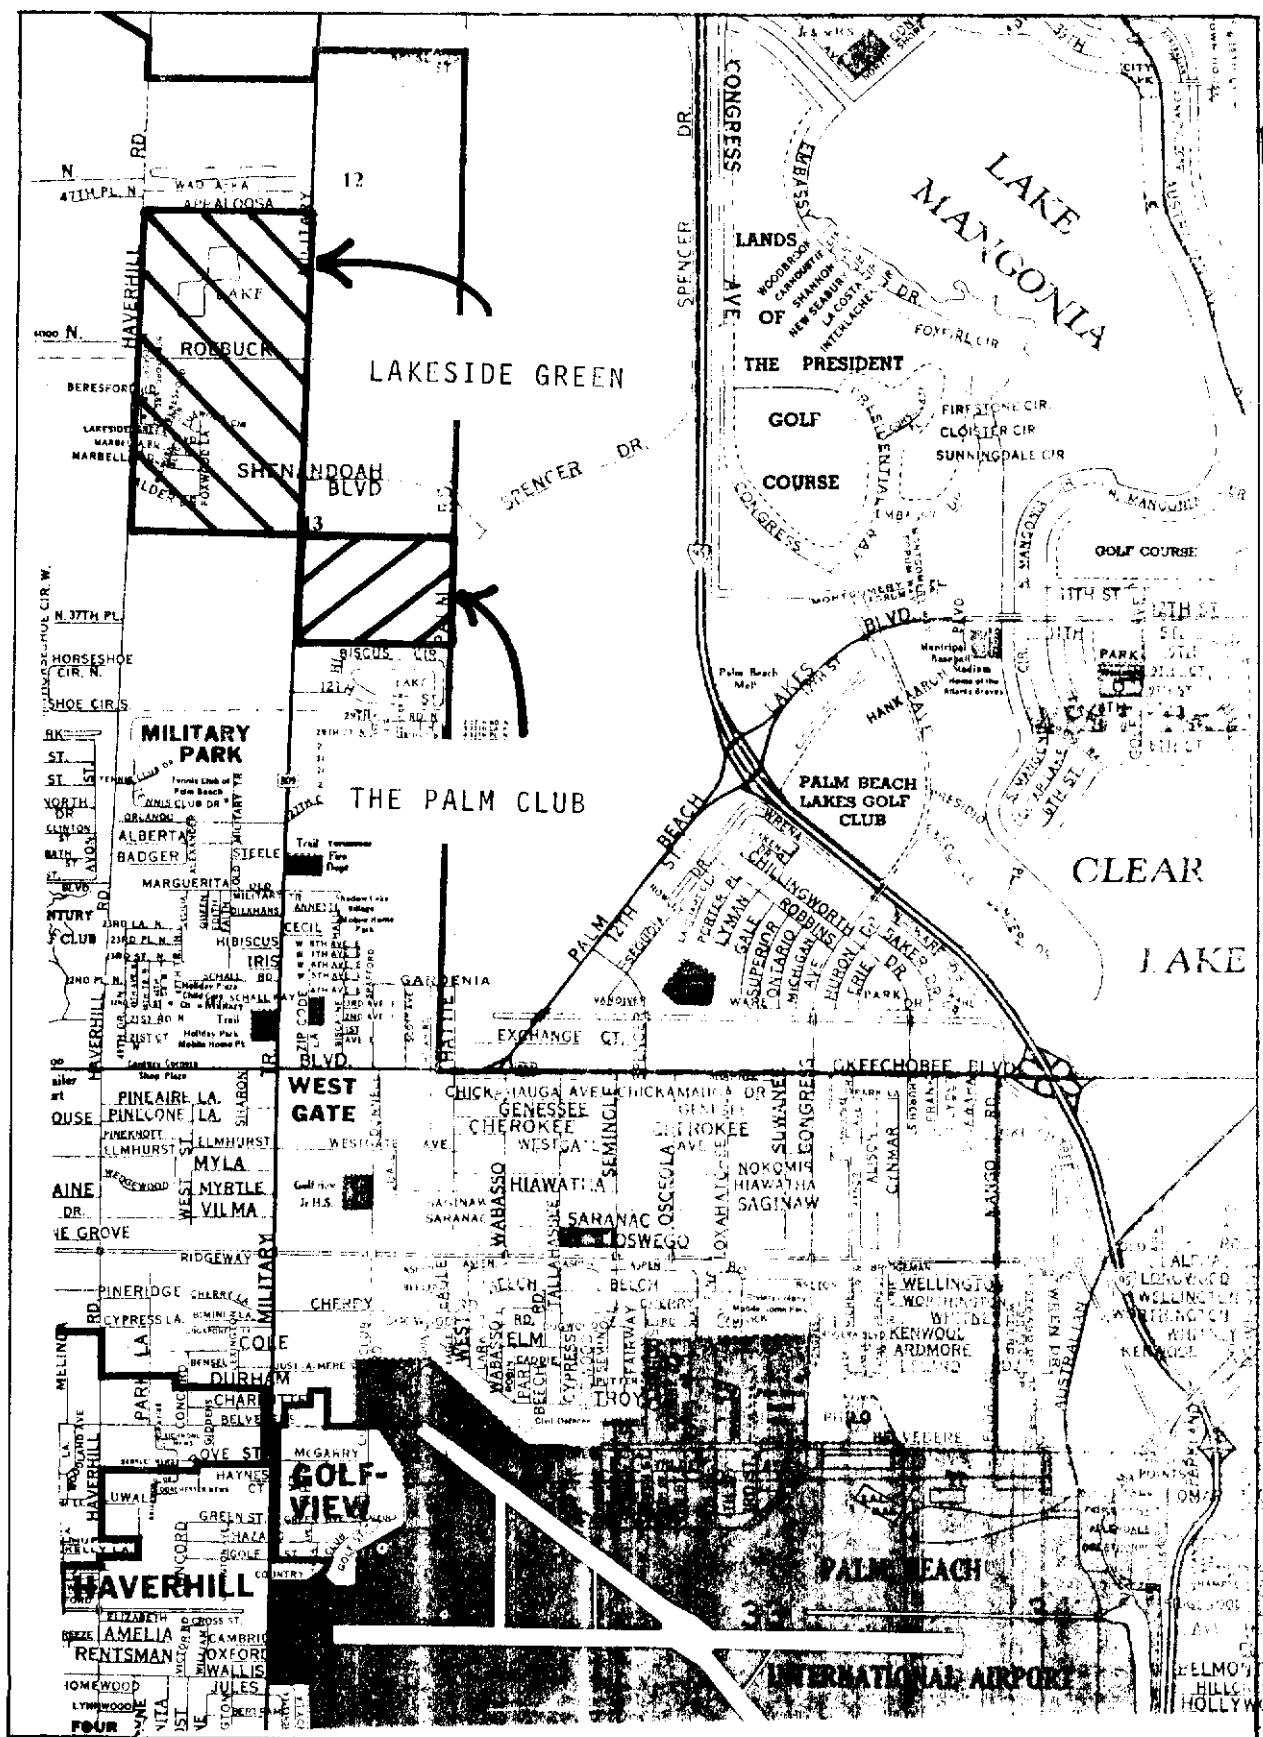
FIGURE 17

This development is located east of Military Trail, north of Okeechobee Boulevard. It was inspected on the afternoon of November 23. Street flooding was evident. Several vehicles had water in them. Ingress and egress from the development was hazardous. The retention areas were over their banks. No homes were flooded. The water control structure for the project appeared to be impacted by the stage in northern Palm Beach County WCD canal "EPB 11-S", which is the receiving body for the project.

This development is located north of the Palm Club, between Military Trail and Haverhill Road. It was inspected the afternoon of November 23. Street flooding was evident but passable. This project discharges to EPB-11.

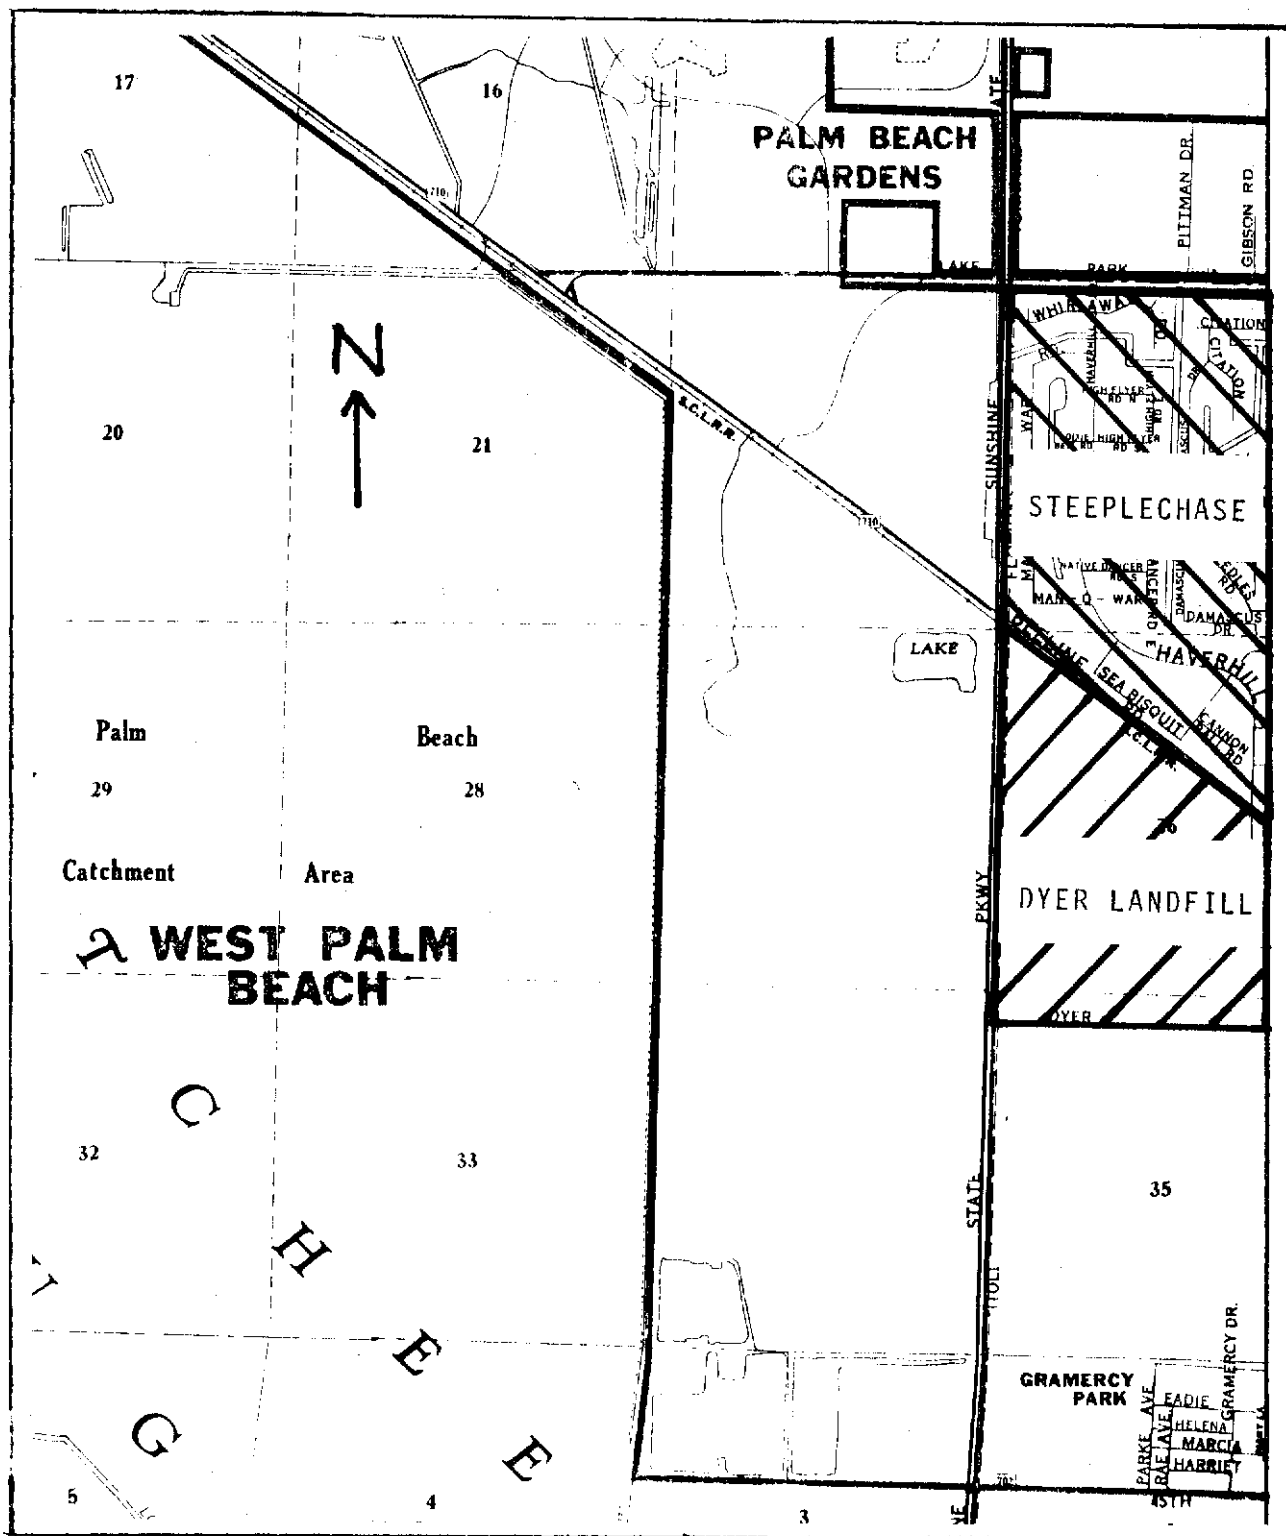
FIGURE 18 LOCATION OF STEEPLECHASE AND DYER LANDFILL

This area is located at the southeast corner of Beeline Highway and Florida Turnpike. It was inspected on the afternoon of November 23. Turbid

discharge was observed at the control structure. The retention area was full. Erosion was occurring on the landfill side slopes. The raw sewage pits appeared to be secure.

This development is located north of Beeline Highway and east of Florida Turnpike. It was inspected the afternoon of November 23. Water was observed to be 2.5 ft deep over some roads. No homes were flooded.
